**A PLANNING ADVISORY NOTE ON
LLANSHAY LANE ALTERNATIVE ACCESS ROUTE TO
REEVES HILL WIND FARM SITE**

16th May 2008

REEVES HILL WIND FARM

Knighton - Llanshay Lane Proposed access route

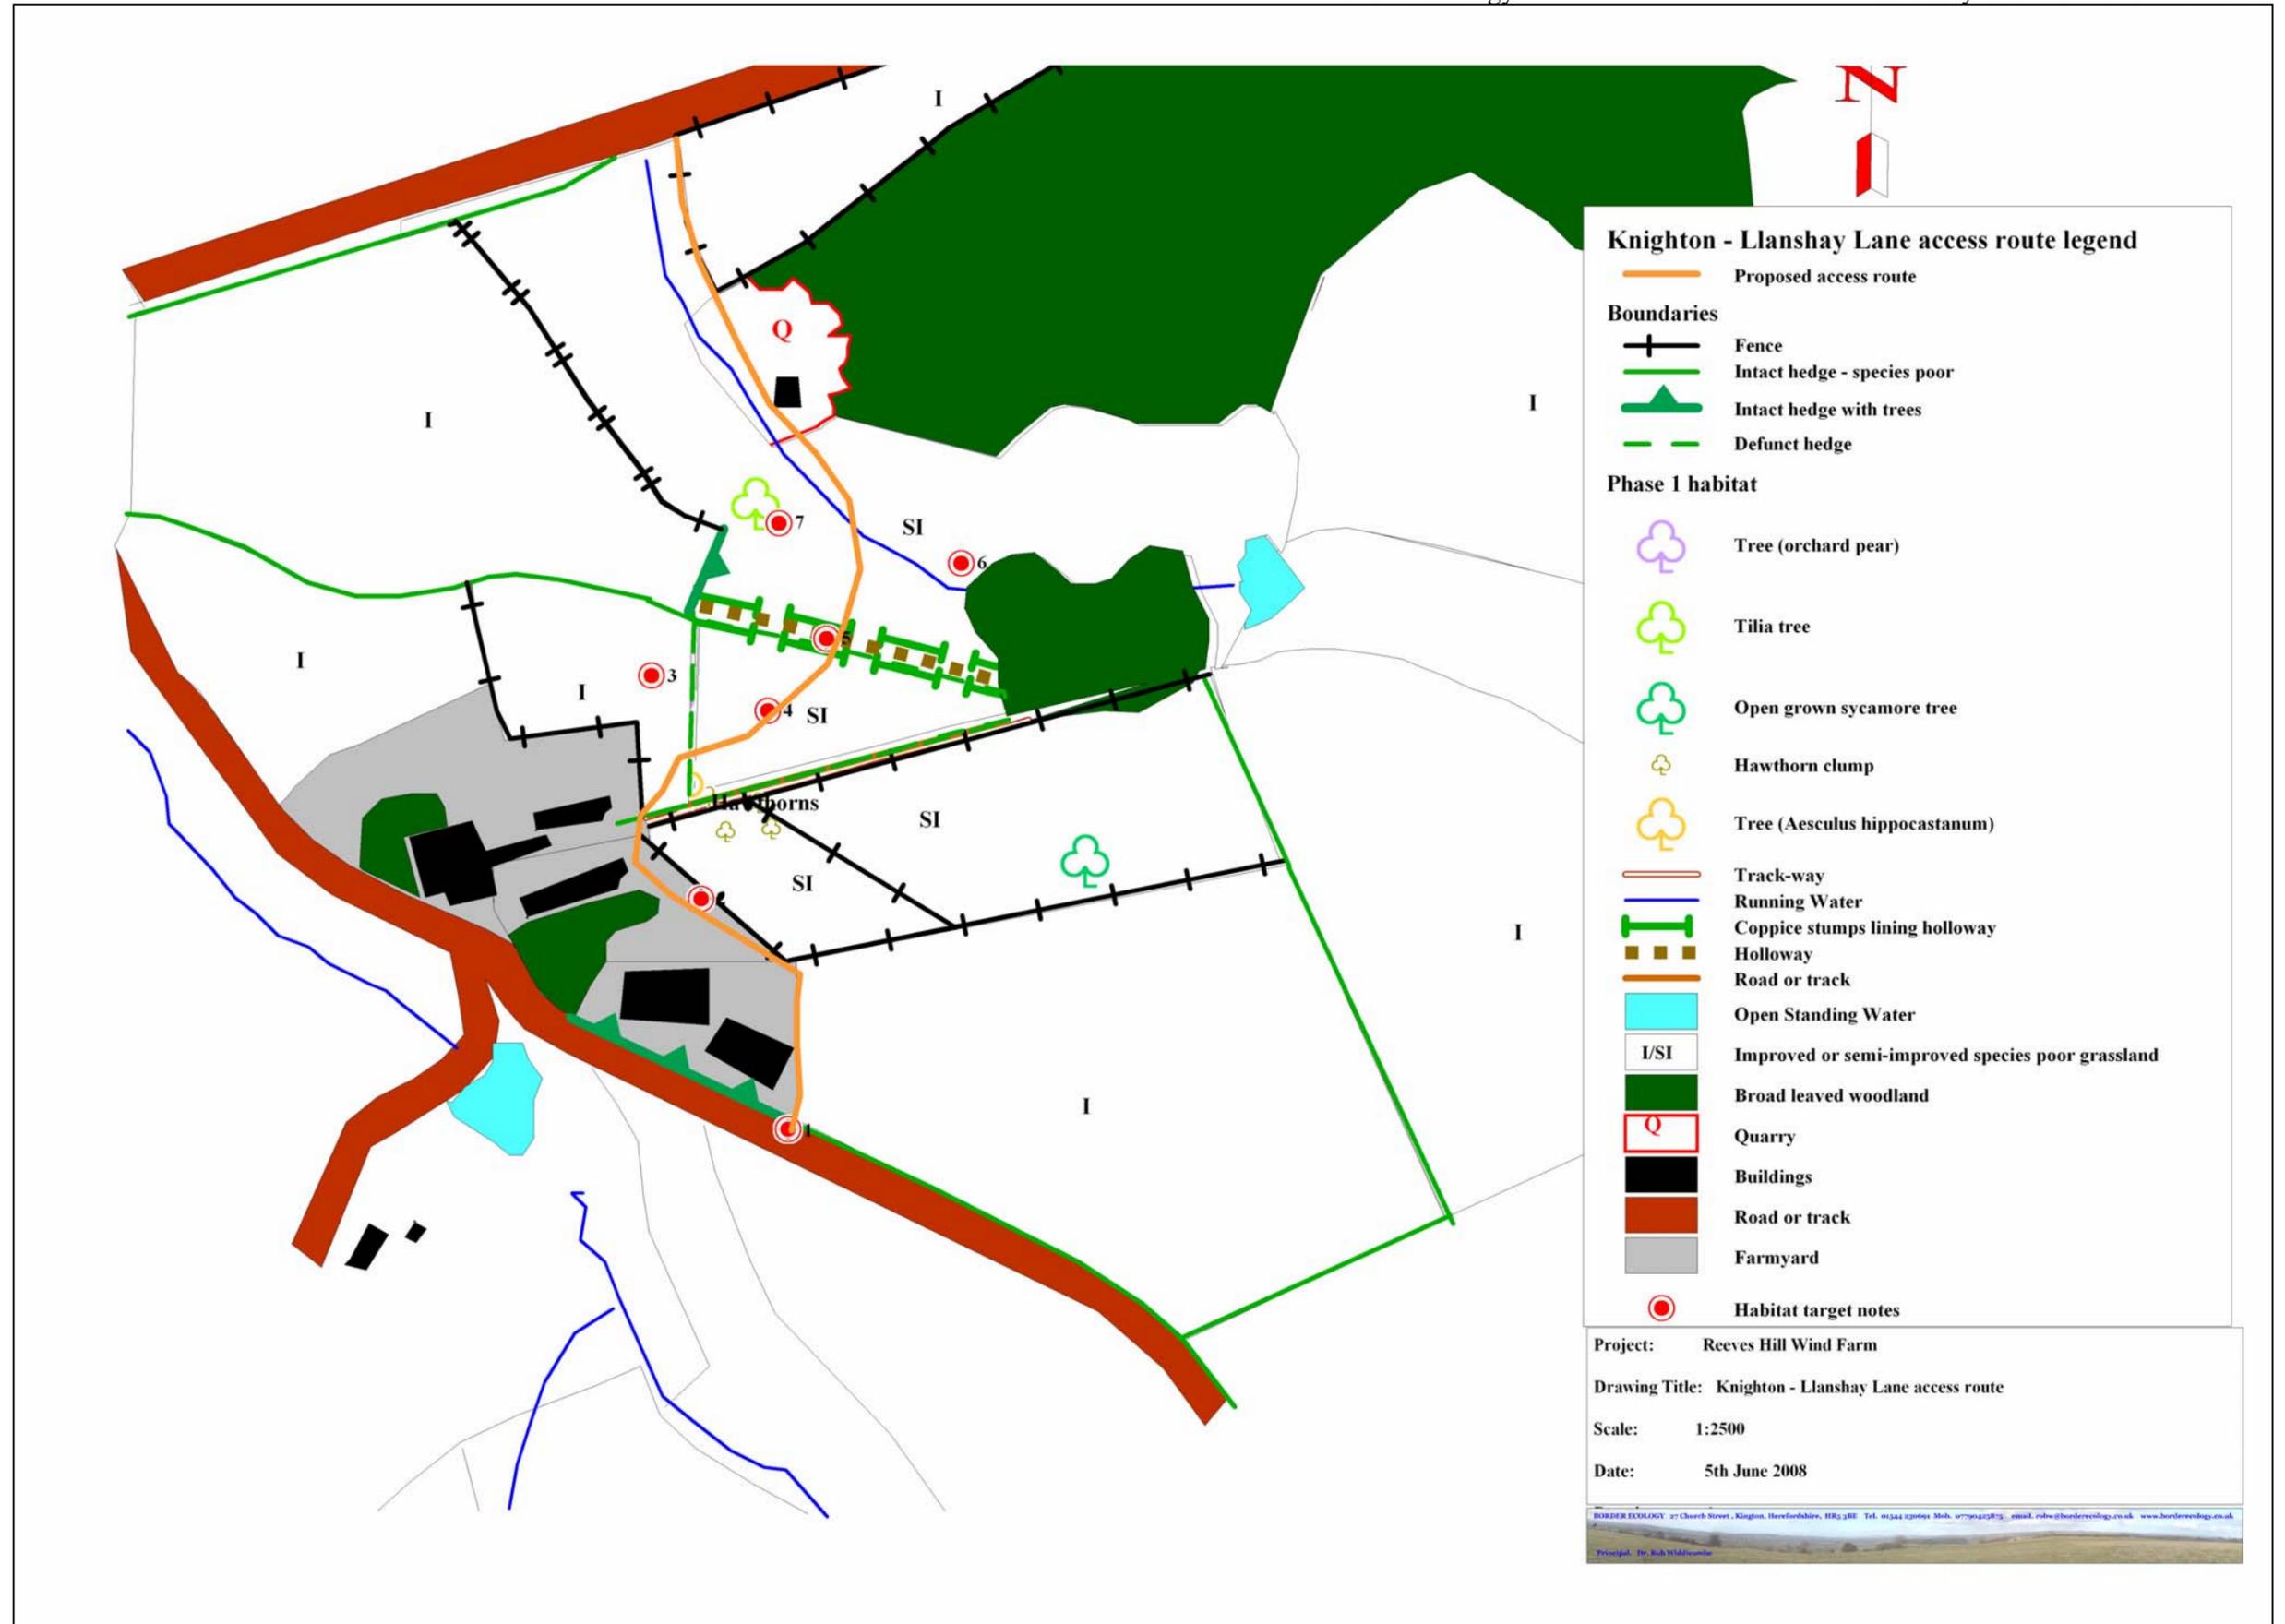
Table 1. Target notes mapped in Figure 1.

Number	Feature	Target notes
1	Roadside bank herbs	<i>Ranunculus ficaria</i> , <i>Alliaria petiolata</i> , <i>Silene dioca</i> , <i>Achillea millefolium</i> , <i>Stellaria holostea</i> , <i>Primula vulgaris</i> , <i>Veronica persica</i> , <i>Mercurialis perenne</i> , <i>Digitalis purpurea</i> .
2	Semi-improved grassland	<i>Festuca ovina</i> , <i>Luzula campestre</i> , <i>Ranunculus ficaria</i> , <i>Achillea millefolium</i> , <i>Rhytidadelphus squarosus</i> (dominant), <i>Cirsium palustre</i> , <i>Ranunculus ficaria</i>
3	Improved grassland	Possible old orchard site
4	Semi-improved grassland	<i>Festuca ovina</i> , <i>Luzula campestre</i> , <i>Ranunculus ficaria</i> , <i>Achillea millefolium</i> , <i>Rhytidadelphus squarosus</i> (dominant), <i>Cirsium palustre</i> , <i>Ranunculus ficaria</i> , <i>Cerastium fontanum</i> ; <i>Cirsium vulgare</i>
5	Old holloway/ stream bed	Lined either side with substantial coppiced stools of <i>Corylus avellana</i> , <i>Crataegus monogyna</i> , <i>Sambucus nigra</i> alongside <i>Betula pendula</i> , and <i>Ulmus procera</i> , Redstart heard singing within the vegetation cover.

6	Semi-improved grassland	<i>Festuca ovina</i> , <i>Luzula campestre</i> , <i>Ranunculus ficaria</i> , <i>Achillea millefolium</i> , <i>Rhytidadelphus squarosus</i> (dominant), <i>Cirsium palustre</i> , <i>Ranunculus ficaria</i> , <i>Cerastium fontanum</i> , <i>Cirsium vulgare</i> , <i>Urtica dioca</i> .
7	Tila cordata (platyphyllos?) stump	Probable pollard remnant of ancient woodland.

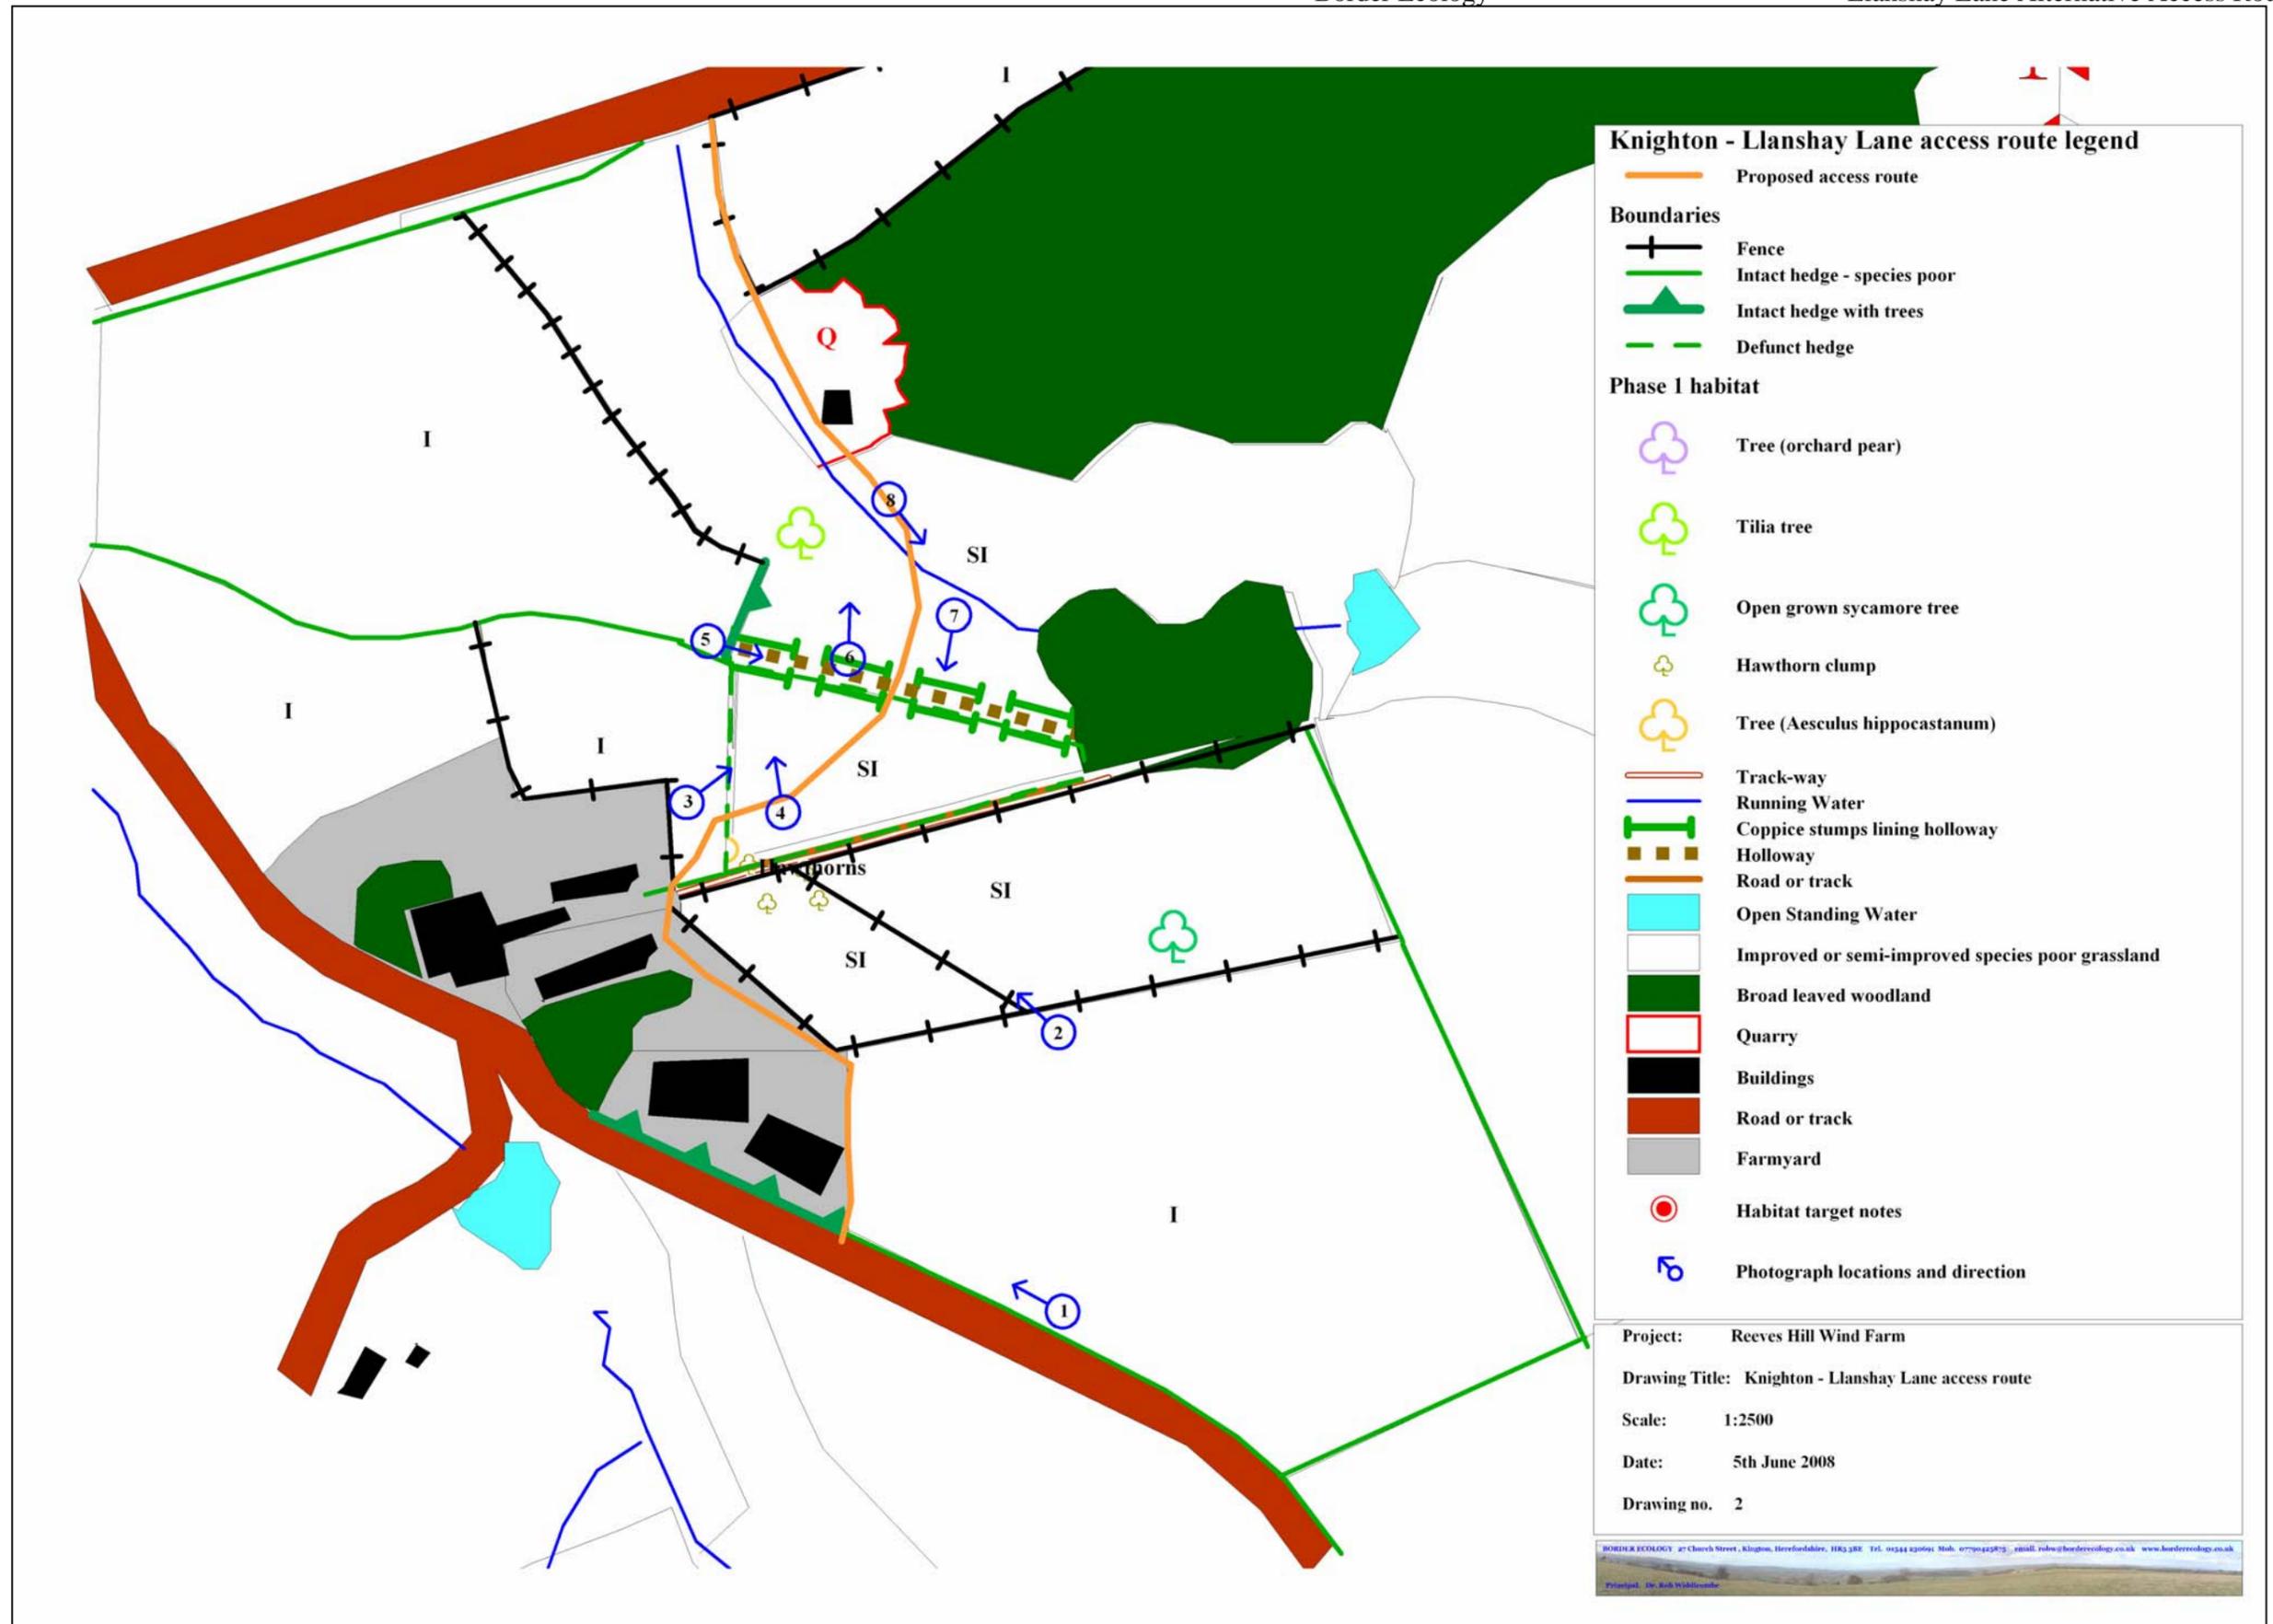
Figure 2. Photographic locations and direction

5.1. Photographic locations and direction are located in Figure 2 followed by the images.

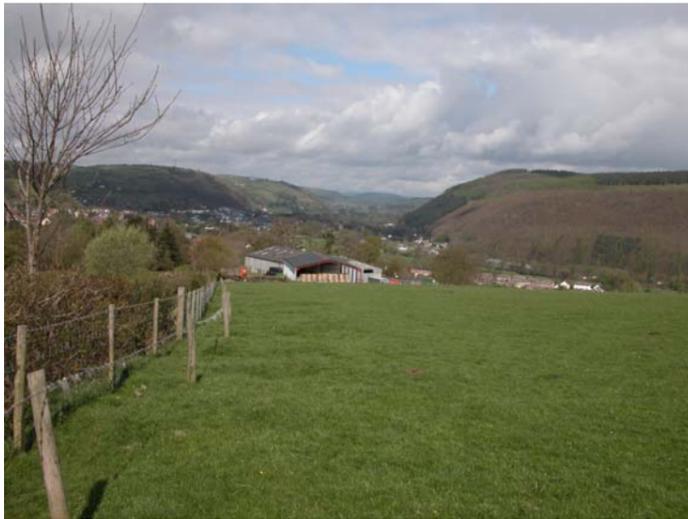
Plate 1. Hedge bordering Presteigne - Knighton road

undertaken. The exit point of the proposed road will breach the Presteigne – Knighton roadside hedge which also has a rich bank-side flora. Reinstatement of this flora is possible through direct planting or through translocation and storage of the ‘turf’ if lifted properly prior to road construction.

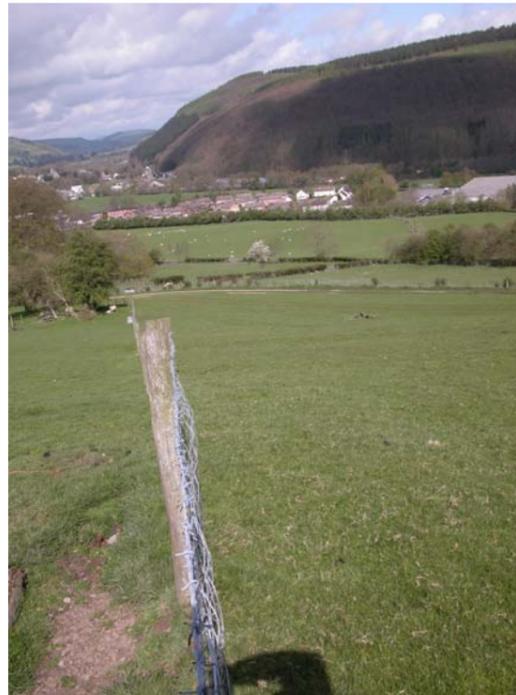
Plate 2. View down slopes to the north

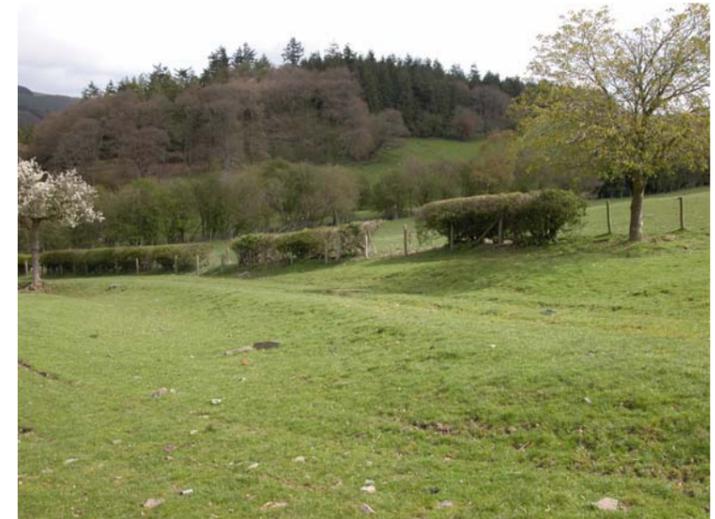
Plate 3. Remnant orchard showing gap for access route

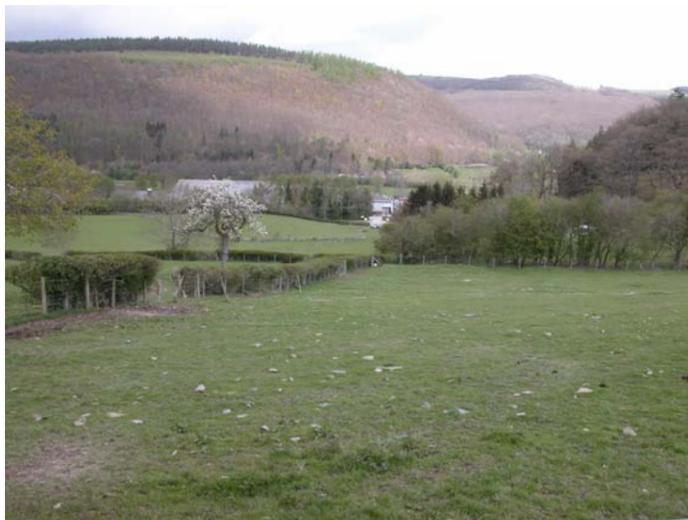
Plate 4. View of orchard and track-way vegetation

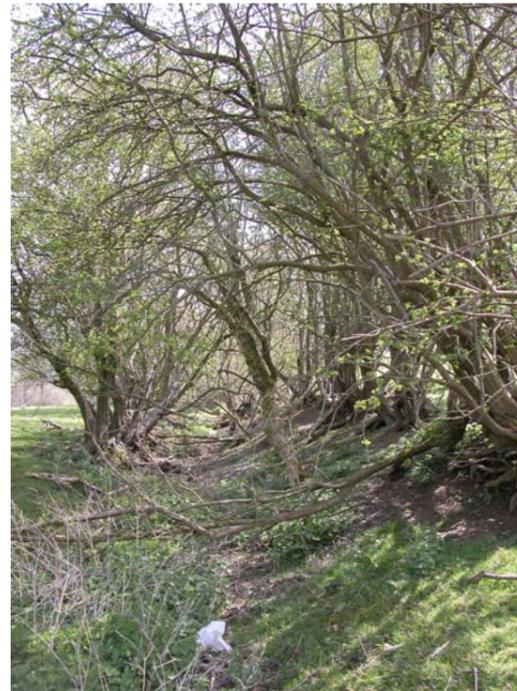
Plate 5. Track-way and fringing vegetation

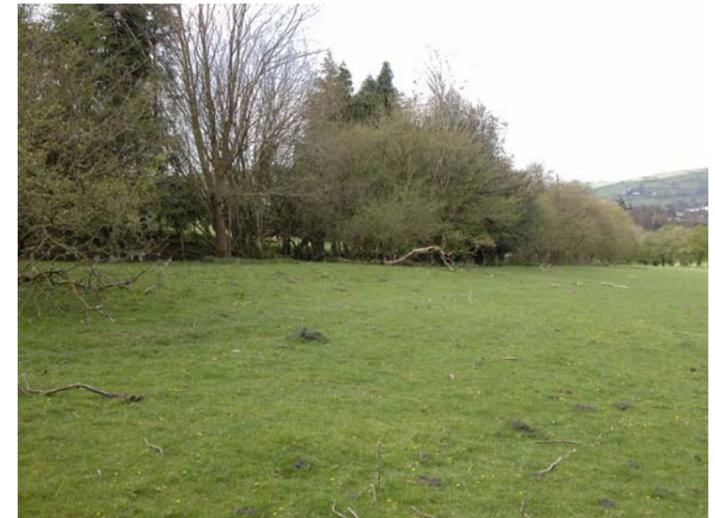
Plate 6. Tree lined track-way view

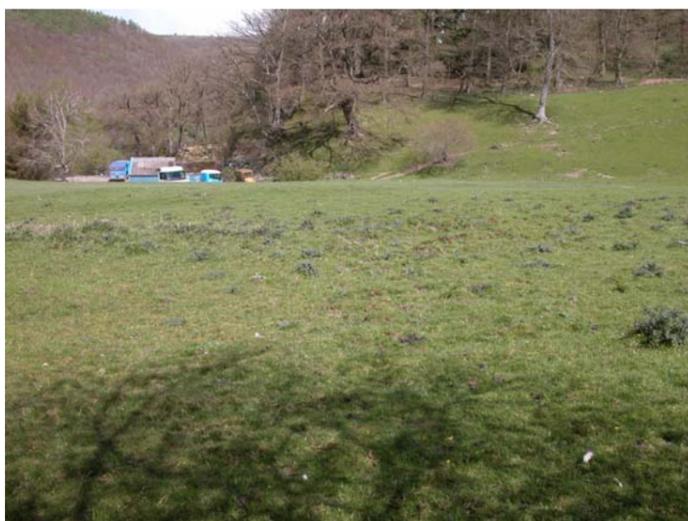
- 3.1. Grasslands on the site were improved or semi-improved but poor in species diversity. The semi-improved fields were located on the steeper slopes of the terrain where cultivations are not possible. Target notes were made of the flora and are presented in Table 1. Significantly wetter conditions in the semi-improved grassland in the valley bottom at the northern part of the site leading to somewhat greater diversity.

Plate 7. Northerly field showing wetter conditions

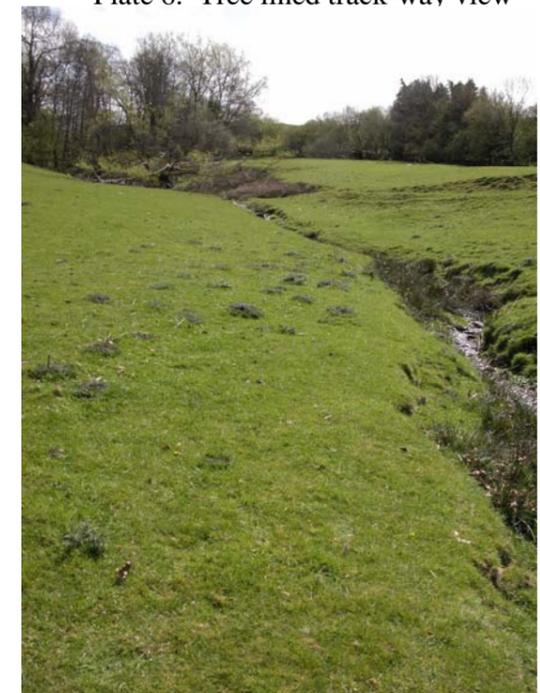
- 3.4. An alder carr (*Alnus glutinosa*) exists upslope of the proposed route on the stream banks. Further up the valley lies a large pond around which is clustered a mix of broadleaved tree species. This area was not surveyed as it is well beyond any influence of road construction effort but may hold great crested newt, a species which is capable of dispersing from this potential breeding pond to hibernation sites provided by areas such as the holloway.

Plate 8. Upstream view of rivulet towards alder wood
